# The First Law of Foundation Stability: Buildings Built on Land Fill will Settle

Jackson County, Florida

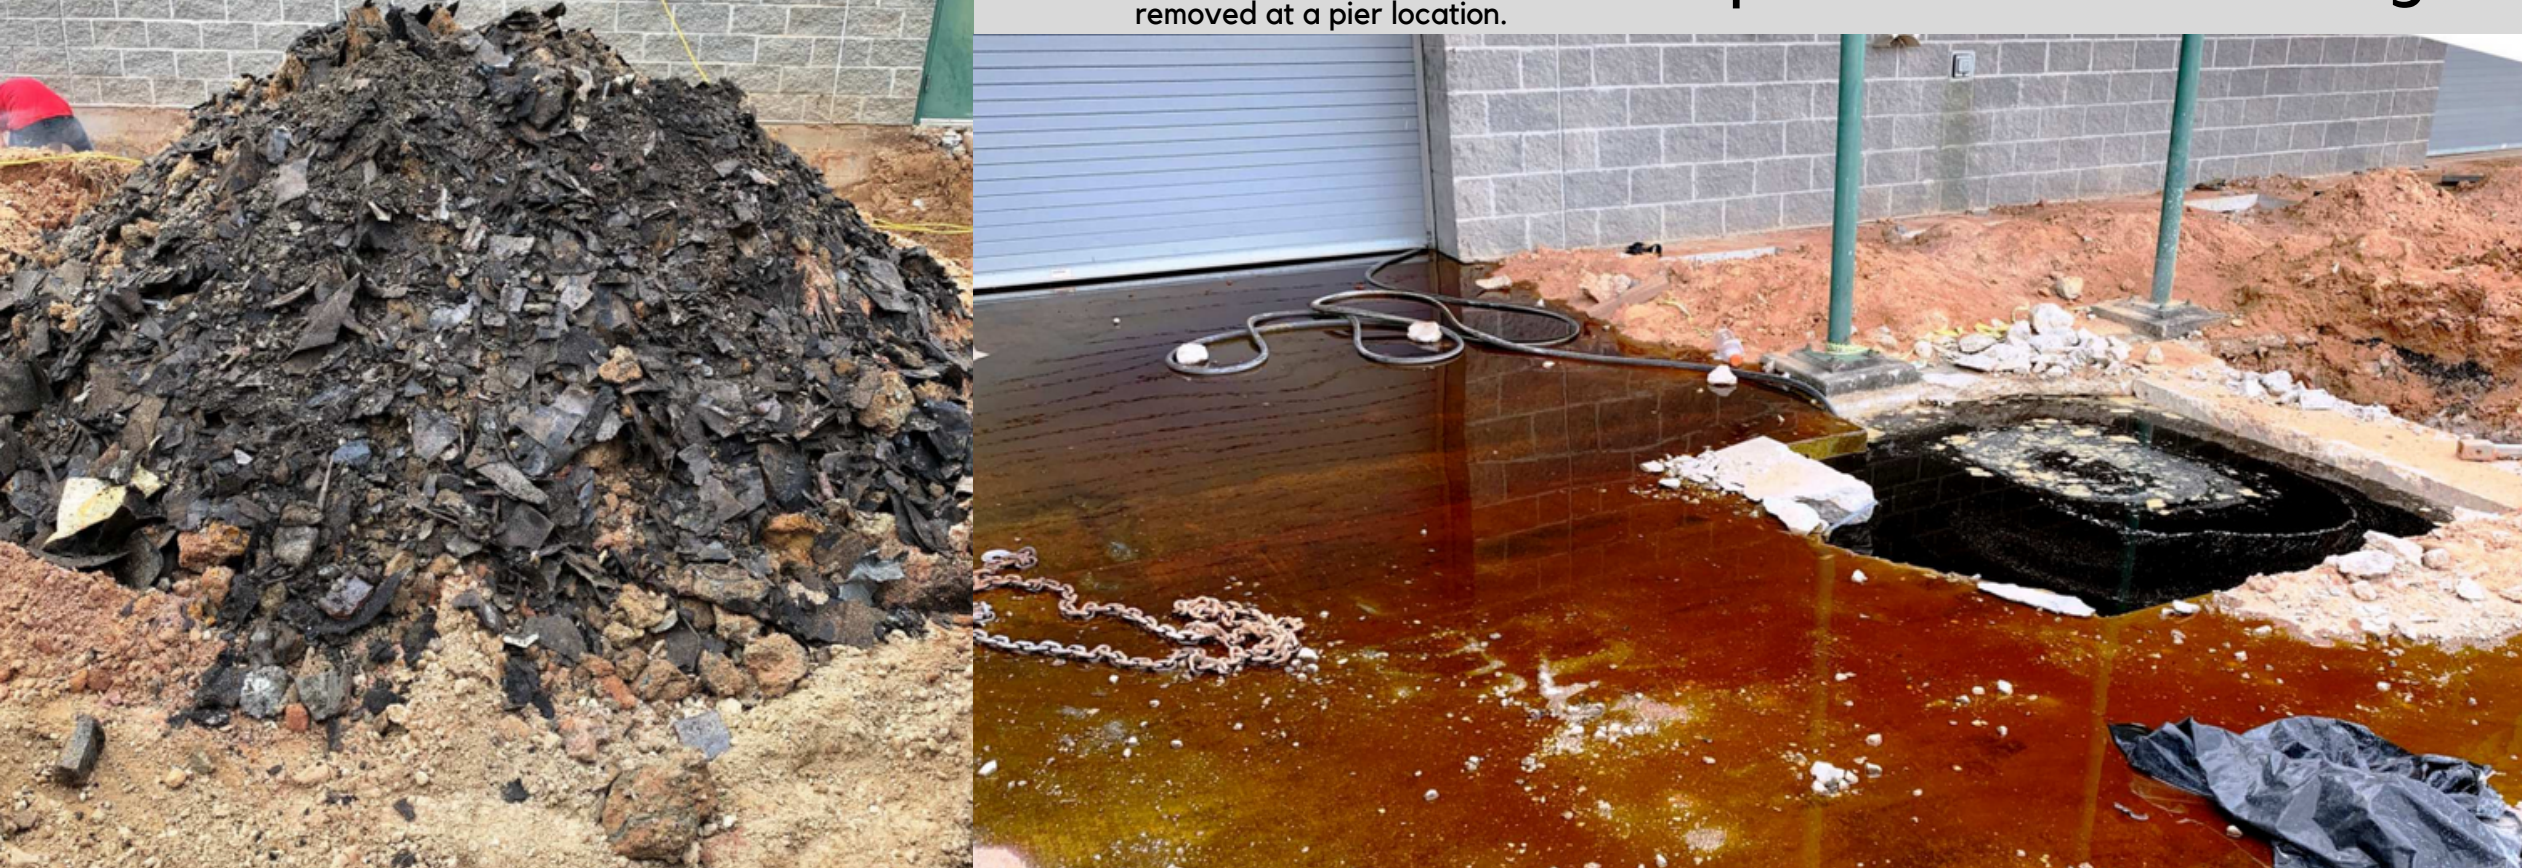
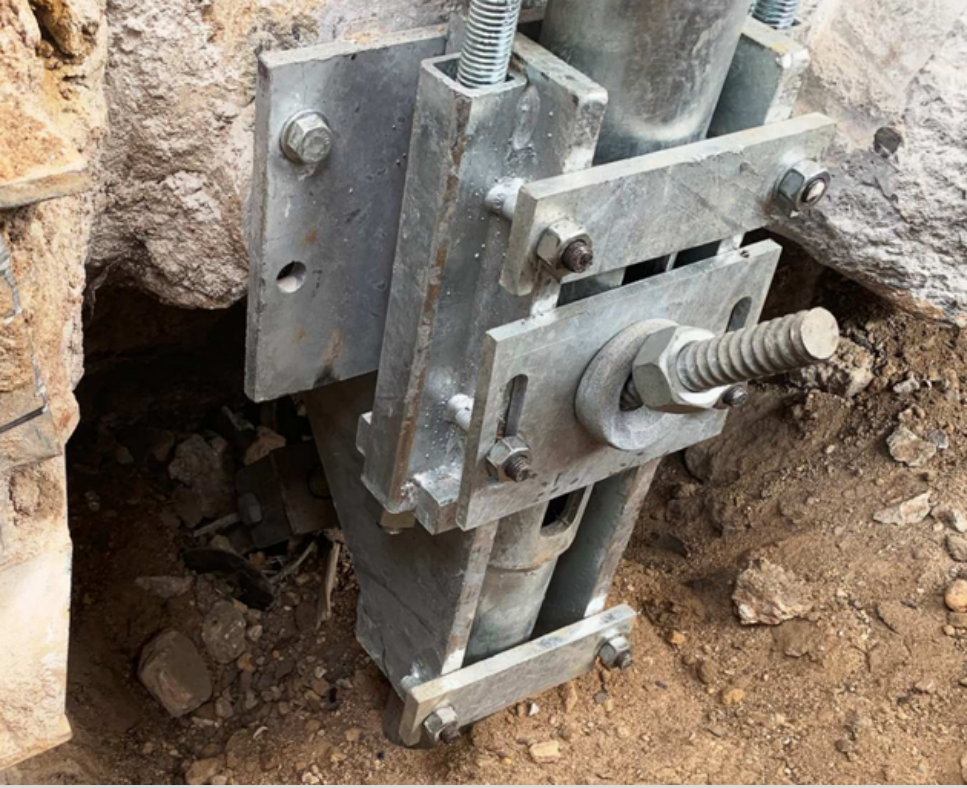
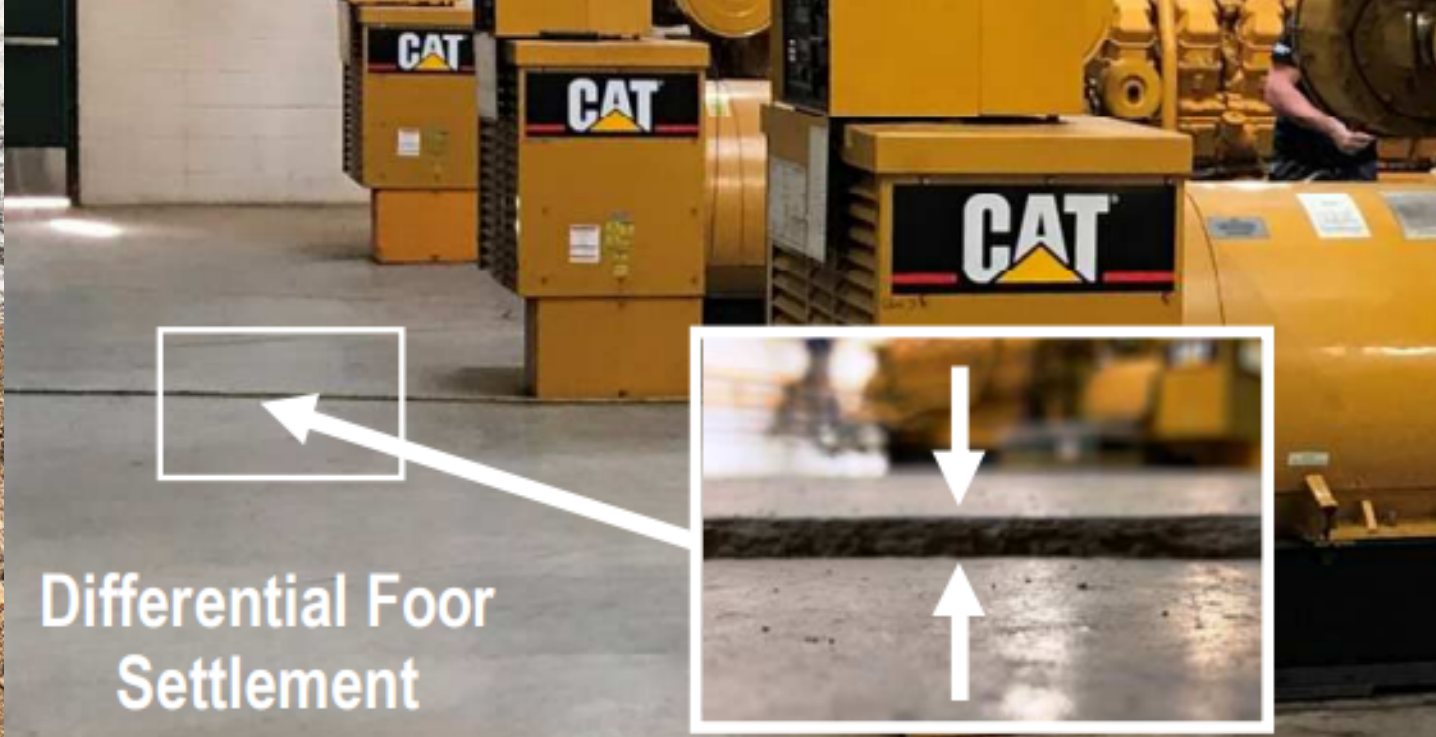
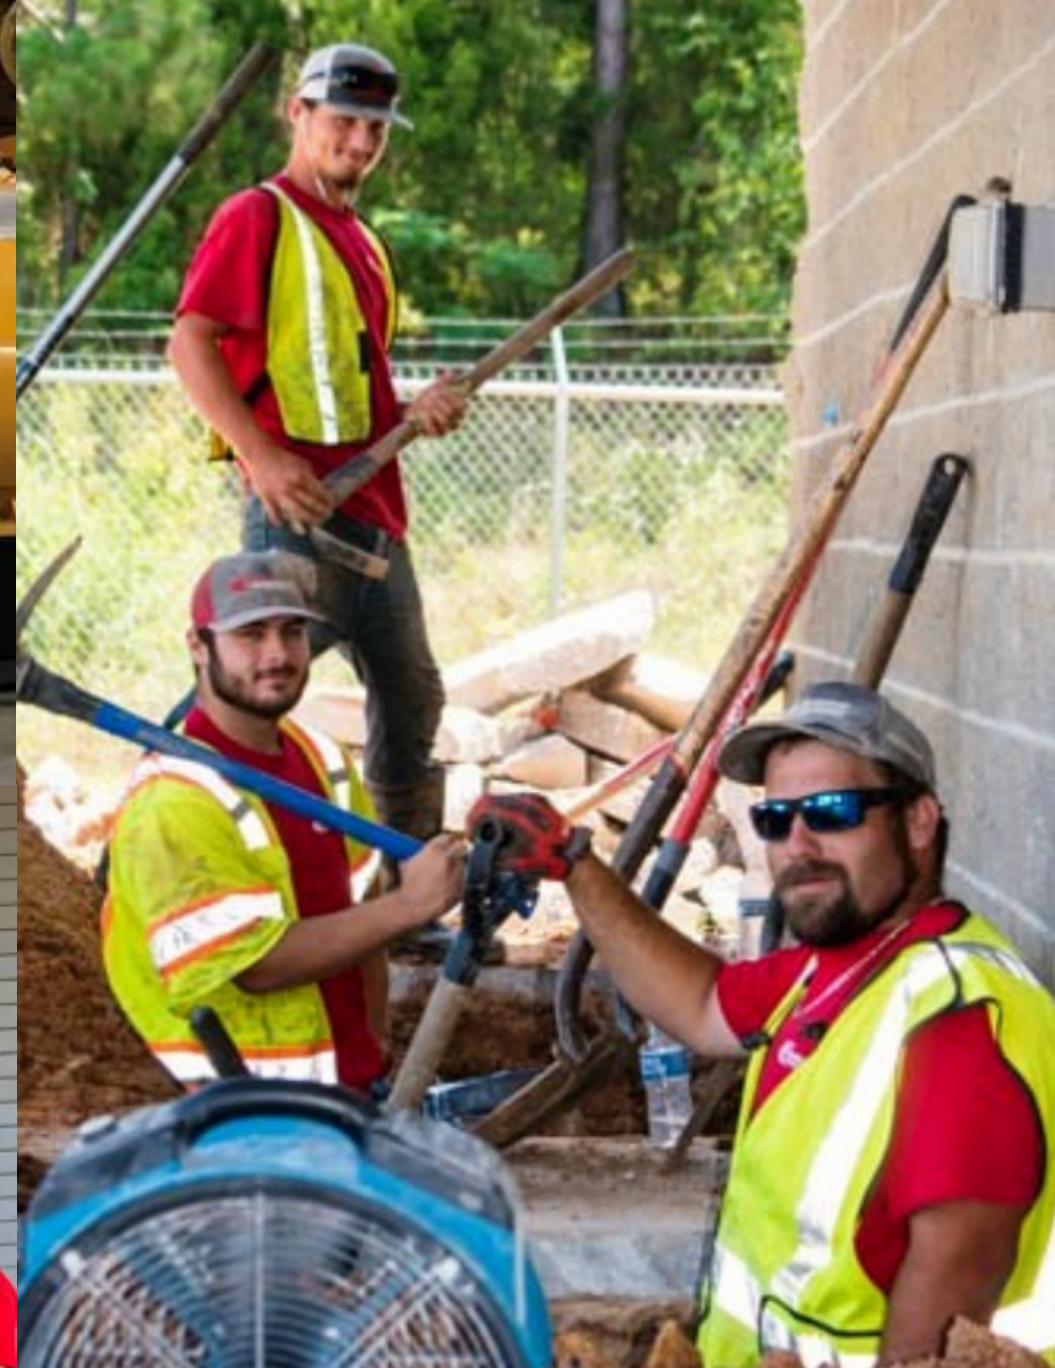
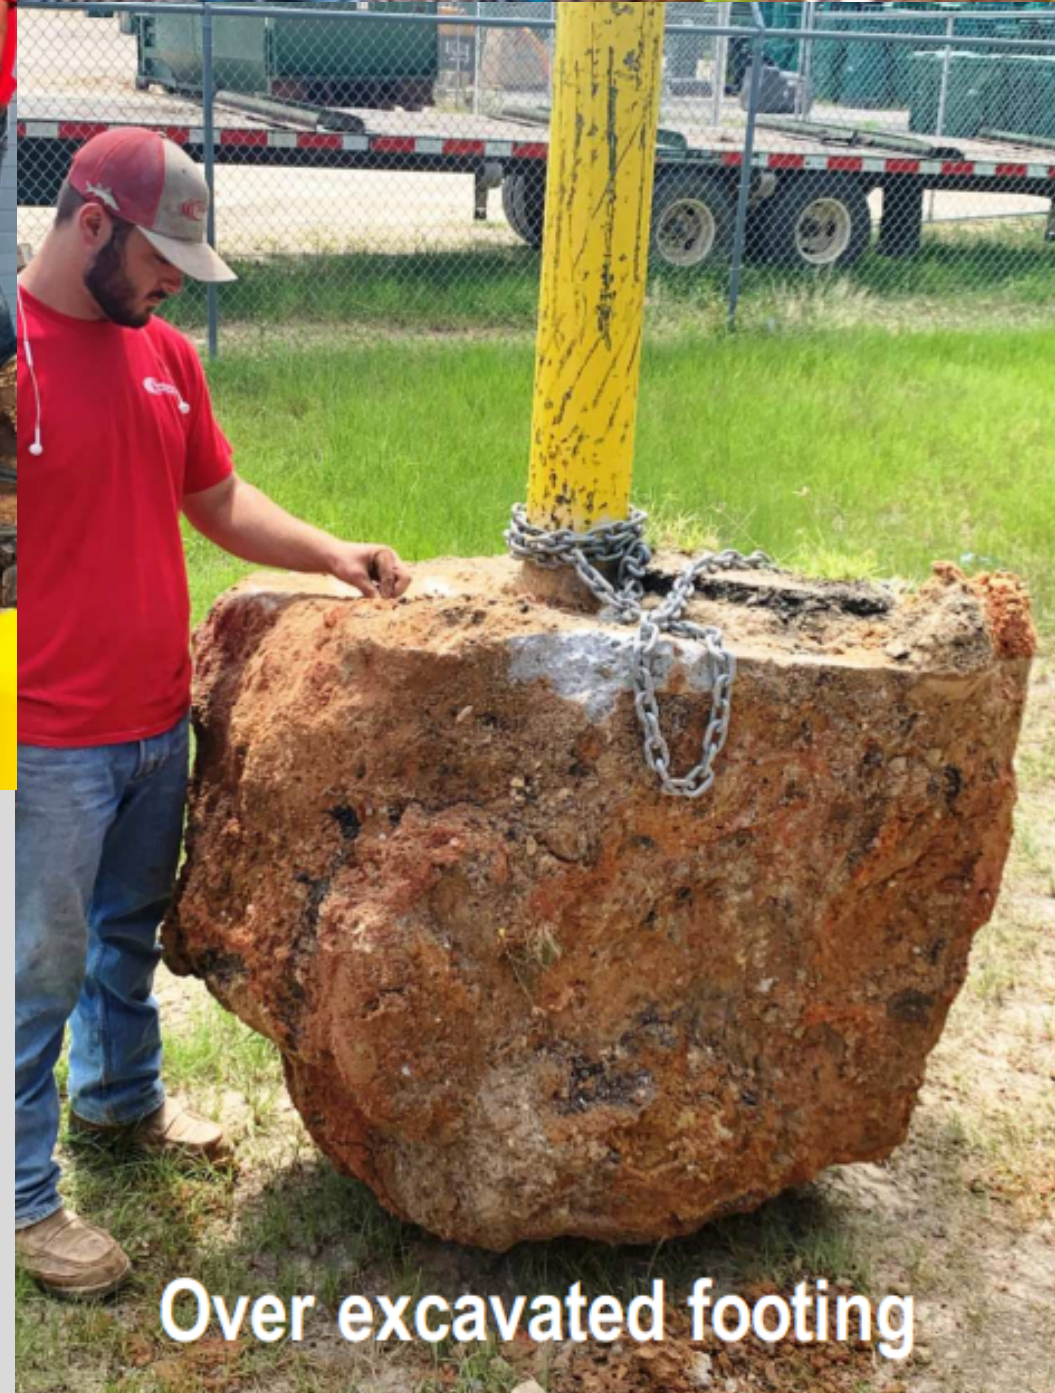
In 2011 a local competing foundation repair company installed 75 push piers under parts of the east wall and floor slab on the south half of the building. There were areas of the concrete slab showing evidence where previous foundation work had been installed. Patches were visible on the interior and exterior masonry and on the slab. No foundation repairs were made on the north end of the building. The plant manager stated that after the previous foundation underpinning and repair was complete, some parts of the building were better than before and some parts were worse. The building continued to move both in the area of previous foundation work and in other portions of the building.

Photos show 2 previously installed push piers, filthy perched water flowing from below the structure and a huge pile of decaying garbage removed at a pier location.

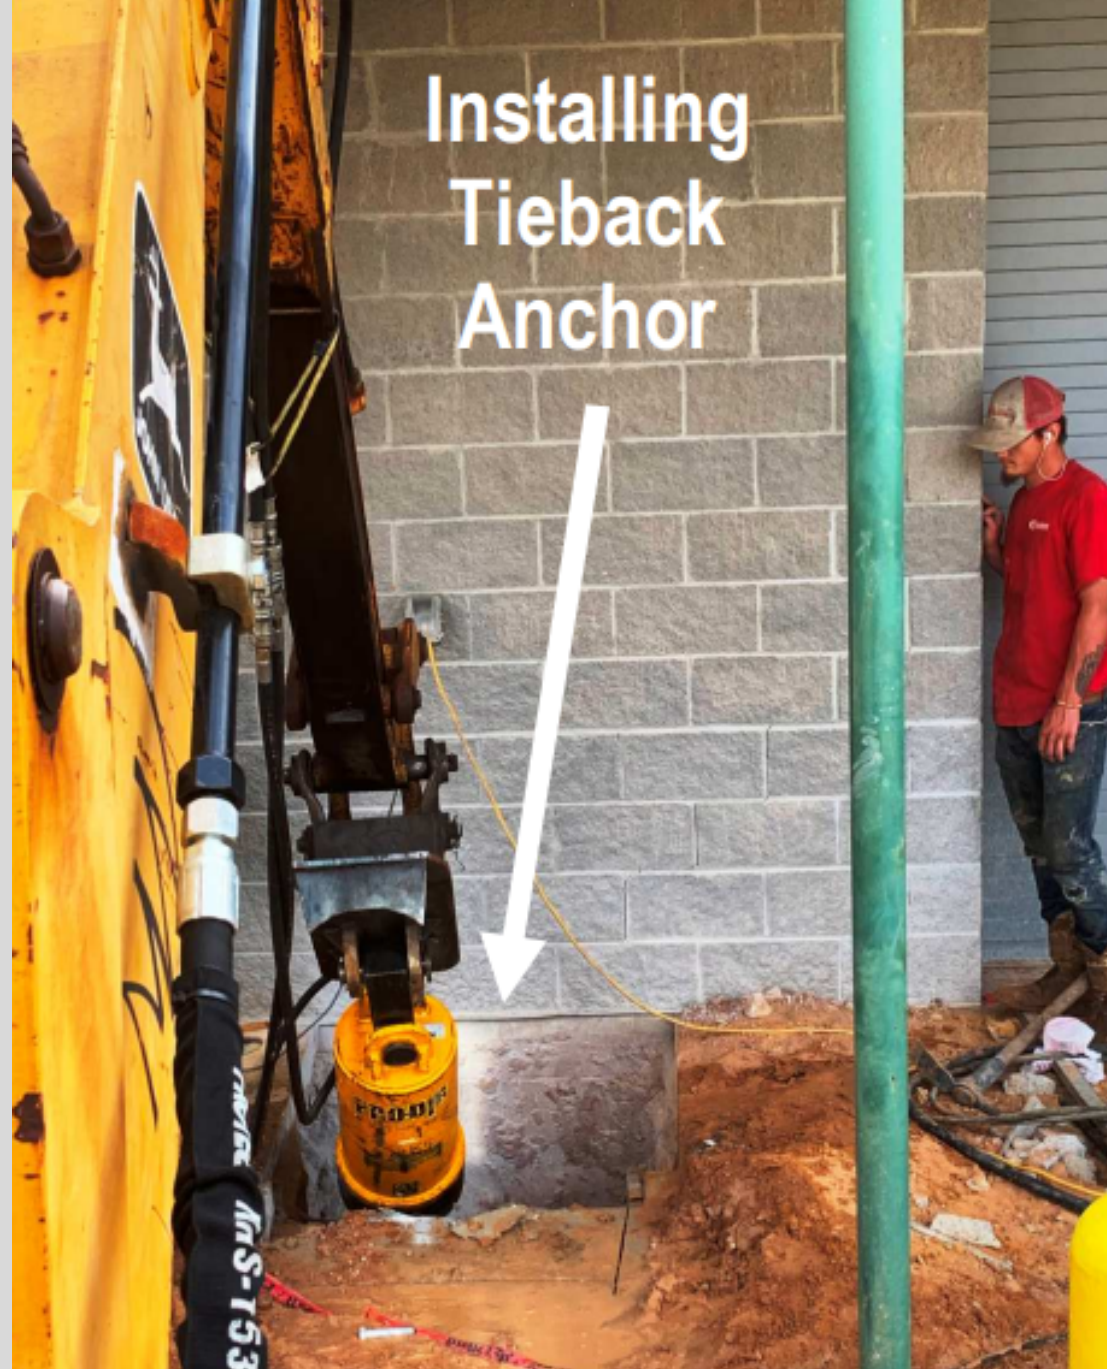
Over excavated footing
