## Class is in Session

### Proactive Foundation Repair Averts Elementary School Catastrophe

Derby, Kansas

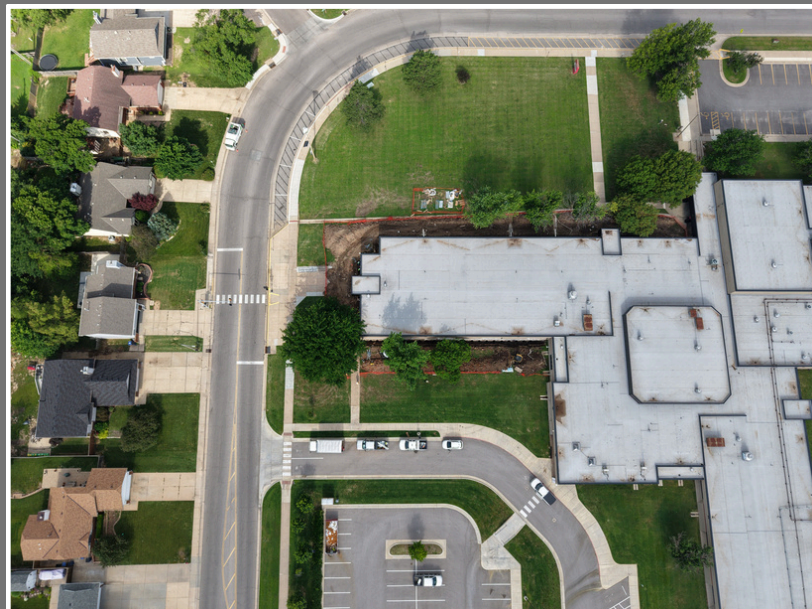
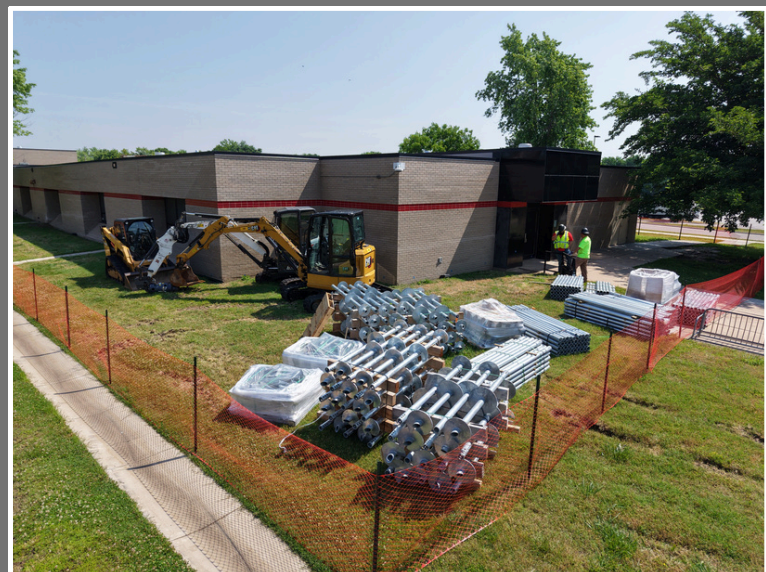
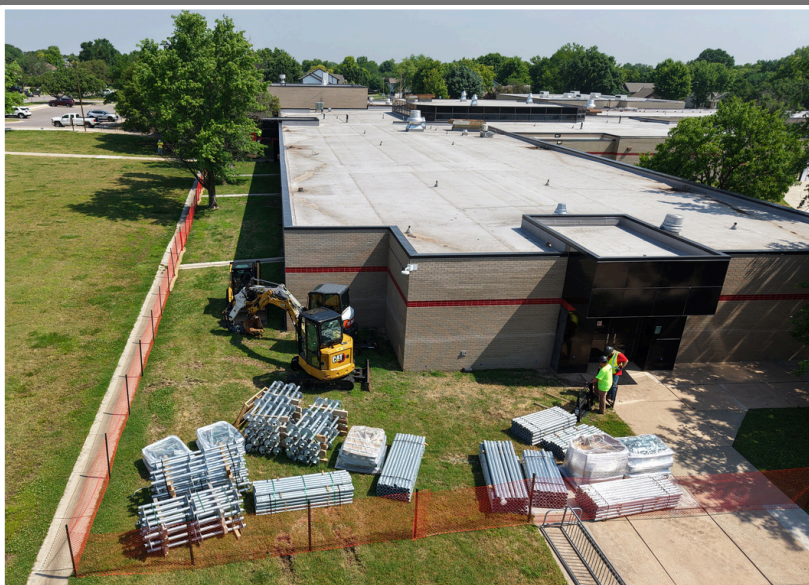
Located in Derby, Kansas, Derby Hills Elementary was built in the early 2000s to serve students just southeast of Wichita. The school contacted IWP after noticing early signs of foundation settlement. While there weren't any major structural failures yet, interior gaps between the walls and floors became large enough to fit a hand through, and minor exterior damage began to appear.

The goal was to proactively address the problem and get ahead of the worsening settlement. Over the course of 3 weeks, IWP's crew installed 88 helical piles to stabilize the affected areas and prevent further movement.
