CASE HISTORY ECP PPB-350-WM Steel Piers™
AND HMI-RR401 POLYURETHANE FOAM

2.2 Million Pounds of Rail Inspection Pit Sections Were Raised with ECP Steel Piers™ and Voids Filled With High Density Polyurethane Foam

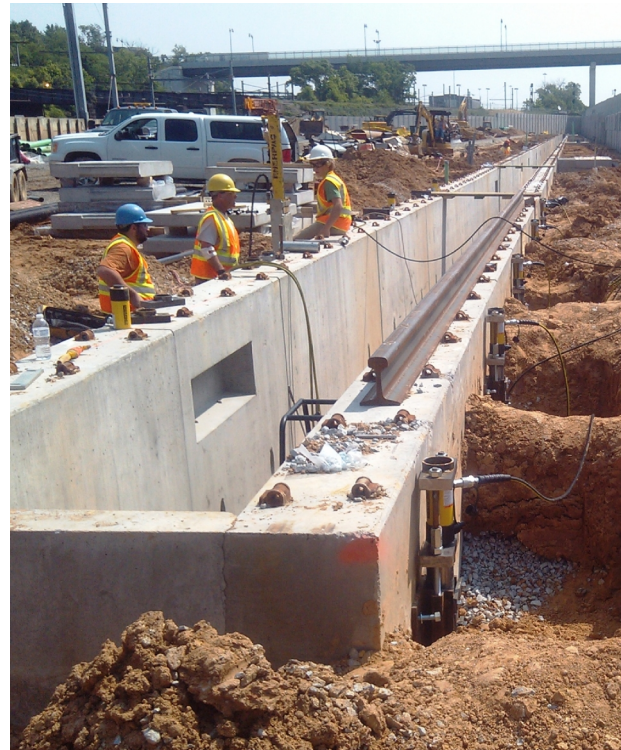
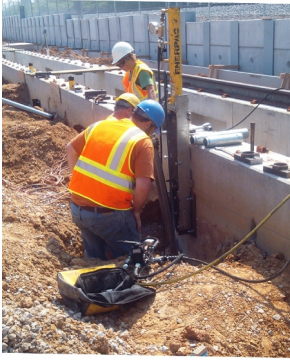
Photographs: At the top and middle left are views showing the installation of the ECP PPB-350-WM Steel Piers™. The pier bracket is mounted to the side wall of the inspection pit section and the three inch diameter steel pier pipe is driven to suitable end bearing and load tested with the yellow hydraulic cylinder shown. The installer monitors the force on the pipe by observing the hydraulic gauge shown in the middle photo.

ECP PPB 350-WM Steel Piers™ were recommended for installation opposite to each other on the outer walls of the concrete inspection pit sections. The wall mounted ECP Steel Pier™ system was selected because it provides ease of installation with the bracket being bolted to the outside walls of the "U" shaped pit. Each pier was advanced through the soil until the pier encountered firm load bearing. Once firm bearing was reached, each ECP Steel Pier™ was field load tested to a proof load, or test force, between 38,000 and 41,500 pounds. The proof test insured sufficient capacity to safely lift each concrete pit section to the proper elevation.

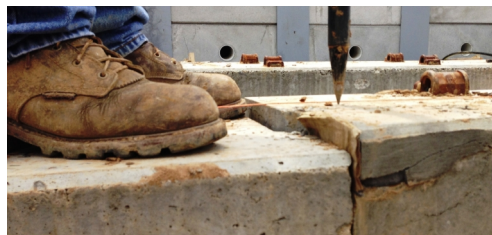
Photographs: Above left shows how the industrial polyurethane was injected into the void. Directly above shows the magnitude of misalignment that was causing problems with the rails. The upper right photo was taken after the pit sections were raised and aligned.

Because there were voids created below the inspection pit sections once the design elevation was restored by the steel piers, the voids were injected with HMI RR401 high density polyurethane foam. Not only did the urethane fill the voids, the designers wanted the foam to provide uniform long term support along the entire 58 inspection pit sections. 14,000 pounds of polyurethane was injected under the pit sections. There were no delays to the train service during the steel pier installation or the polyurethane injection process.

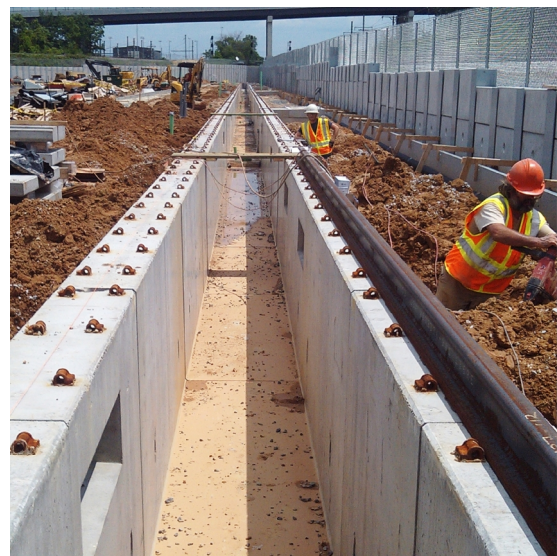
The photograph at right shows the inspection pits after the 116 ECP Steel Piers™ were installed, the lost elevations were recovered, the sections aligned and the polyurethane injected into the voids below the sections of inspection pits. Notice that the rail is being installed on the right side.
