CASE HISTORY

ECP STEEL PIERS™ STANDARD MODEL 350

**Dixie National
Forest Service Office,
Cedar City, UT**

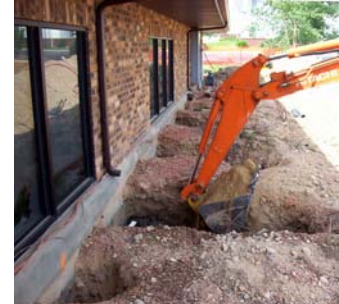
Photographs: At the top is a view of the settled structure showing the large depth of fill below the foundation. At top right the excavations are prepared at pier locations along the perimeter of the structure. Above right shows how the foundation was prepared for mounting the pier bracket. The technician is smoothing the face of the stem wall. The bearing area under the footing was also similarly prepared. At right a technician installs one of the drive stands that were used to advance the pier pipe through the soil to end bearing.

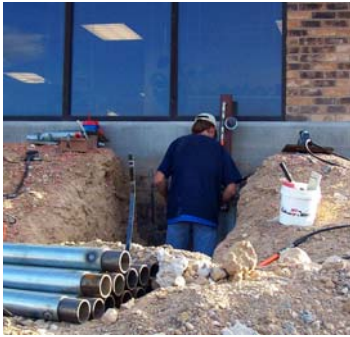
Each pier was advanced through the consolidating soil until the pier encountered firm load bearing. Once reached, each ECP Steel Pier™ was field load tested against this bearing stratum to a force greater what was required to support the structure. Field load testing each pier after reaching end resistance verified that the bearing stratum was suitable for long term support. This load testing also determined a factor of safety for each pier placement against future settlement. In the case of this project, the field test loads were on average 155% percent above the working load requirements providing an average factor of safety over 2.5!

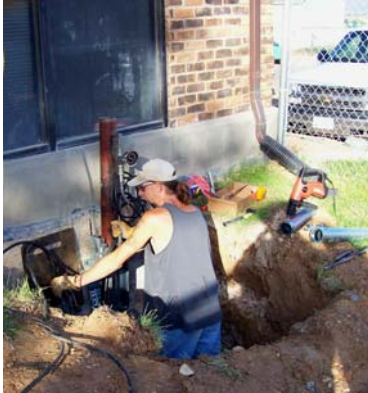
At each pier location a pier bracket was attached to the foundation. Once all piers were installed to end bearing and the load capacity verified, the structural load was transferred from the failing soil under the structure to the verified bearing stratum deep below the surface. This gentle and uniform load transfer was accomplished by banks of hydraulic jacks that were all connected through manifolds to electric hydraulic pumps. One jack was installed on each pier bracket to accomplish the load transfer and recovery of lost elevation.

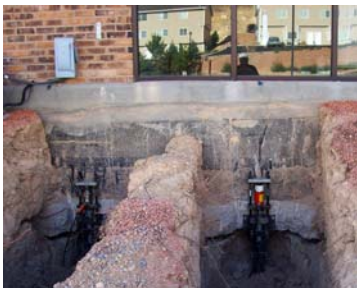
There was minimal disturbance to the building's occupants during the restoration process. Because ECP Steel Piers™ were installed using quiet, vibration free hydraulics, it was "business as usual" in the office during the underpinning installation.

Photographs: Above the technicians are installing pier pipe using quiet and vibration free hydraulics. At left center, the structural load is being transferred from the concrete footing to the pier systems using multiple hydraulic jacks. At left, one can see how the columns were lifted along with the building. One steel pier was situated on each side of the column footing making lifting the columns a simple procedure. The photo at bottom left shows how recovering the lost elevation was accomplished. All hydraulic jacks were connected together through a manifold system and actuated using electric pumps for gentle and uniform lifting. Below are views of two Model 350 ECP Steel Pier™ placements. Notice amount of lift accomplished on this project and the final configuration of the pier system.
