Settling Bay Area Home Repaired Rock Solid

Project Summary	
Project:	Phister Residential Restoration
Engineer:	Clifford Tanaka, PE – Novato, CA
Installer:	Bay Area Underpinning - Vallejo, CA
Product Installed:	ECP PPB-300 Steel Pier™
Number of Placements:	43
Depth to Bearing:	45 to 70 feet
Ultimate Limit Capacity:	68,000 lb
Recovered Elevation:	Up to 4-3/4 in
Average Test Load:	14,850 lb
Average Lifting Load:	4,100 lb
Average Factor of Safety:	3.6 : 1 Test Load to Working Load 16.6 : 1 Ultimate Limit To Working Load

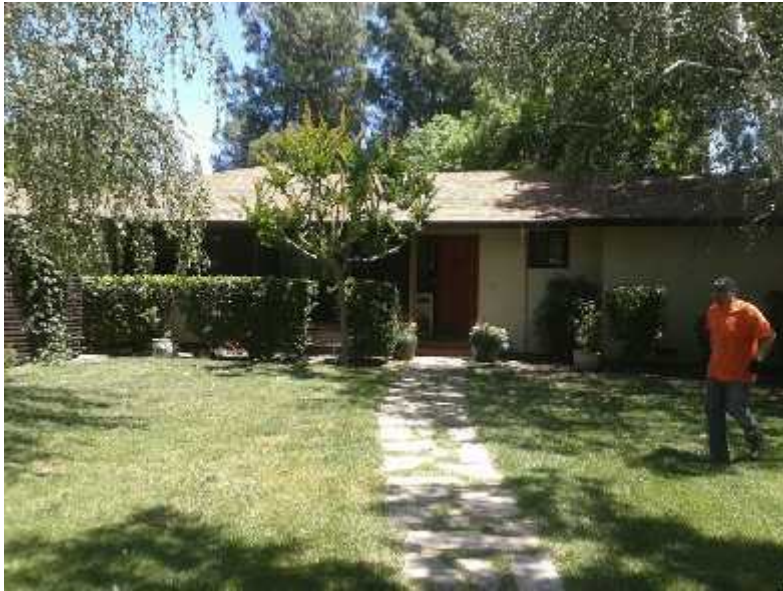
Earth Contact Products' Steel Piers™ were used to raise this settled residence. The engineer of record calculated that the structure weighed slightly less than 1,000 pounds per lineal foot at the perimeter. Calculations determined that the concrete footing would be able to support a span between piers of 7-1/2 feet with an average working load on each ECP Steel Pier™ of 12,700 pounds.

ECP PPB 300 Steel Piers™ were recommended to be installed on the perimeter of this structure to provide support and to recover lost elevation. The ECP Steel Pier™ system with the under the footing bracket was selected and installed at each pier placement location. Because this product provided ease of installation and each pier placement required only a small, hand dug excavation, there was minimal disruption to the yard during construction.

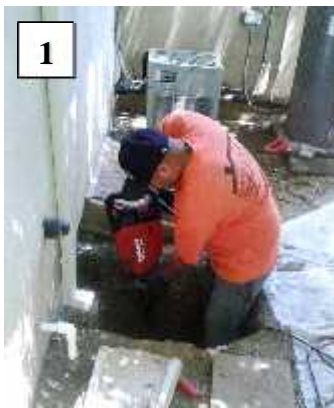
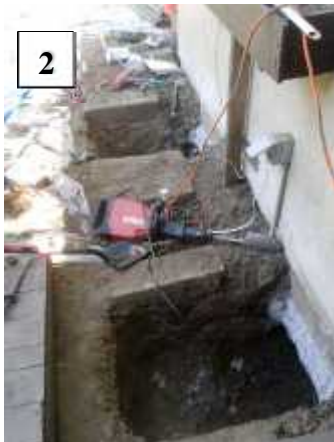
Photos 1 & 2 are views showing the preparation of the area for pier installation. The small excavations are hand dug and then a technician uses a chipping hammer to prepare the edge of the footing smooth and vertical and the underside of the footing smooth and level.

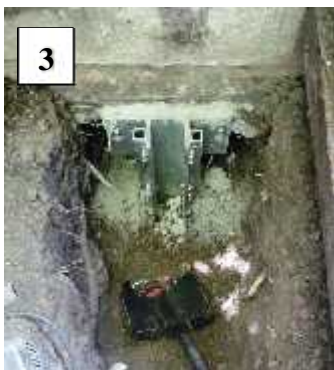
Photo 3 shows an ECP PPB-300 under footing bracket carefully installed to the foundation.

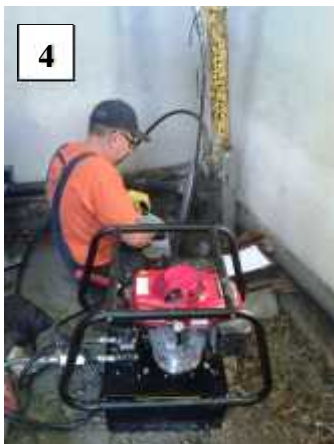
Photograph 4 shows a technician installing the steel pier pipe into the soil. Each section of pier pipe is 3-1/2 feet long and the process continues until the pier

encounters rock or a suitably firm bearing stratum.

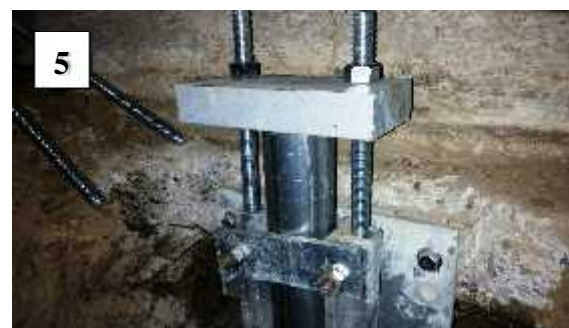
Photo 5 is a close detail of the finished installation prior to backfill. The ECP Steel Pier™ Assembly is easily adjusted should geologic conditions change.
