ECP STEEL PIERS™ MODEL PPB-350

**Leaning Grain Silo
Restored with
ECP Steel Piers™
Garrison, Iowa**

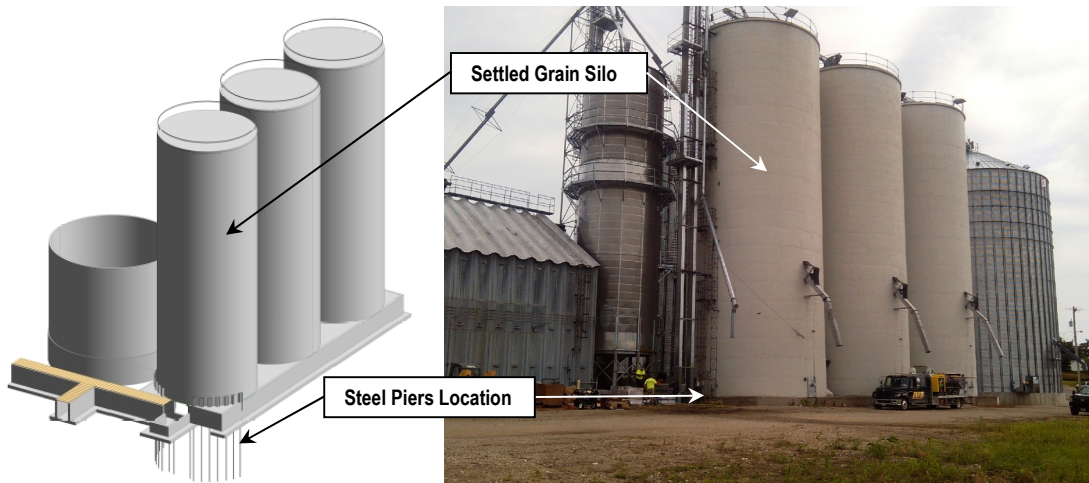
Poor drainage caused softening of the soil underlying the foundation at one side of a 100 foot tall, 30 foot diameter grain silo. The total structural weight of the silo was estimated at 680,000 pounds and the silo has a grain capacity of 1,265 tons. The engineer estimated that the northwest portion of the foundation had settled four inches causing the silo to tilt.

The engineer concluded that the settlement was the result of compromised support under the foundation as a result of moisture intrusion through a crack between the walls and slab. The subsequent freeze and thaw cycles over several years expanded the foundation crack allowing more water intrusion each year, which eventually permitted flow and erosion of the underlying soil. The moisture laden soil under the footing and void under the silo caused the failure of foundation support for a part of the structure. Maximum settlement exceeded four inches.

The engineer recommended deep foundation piles to transfer the structural load from the failing soil under the footing to a suitable load bearing stratum below the surface. ECP Steel Piers™ were selected for rapid repair and restoration of lost elevation with the least disturbance to the weak soil adjacent to the silo foundation. The PPB-350 Steel Pier System uses 3-1/2 inch diameter pier pipe. For additional stability, and to increase the moment of inertia (stiffness) of the steel pier, 4 inch diameter pipe sleeves were installed over the pier pipe. The sleeve joints and the pier joints were staggered to strengthen the coupled joints of the pier system.

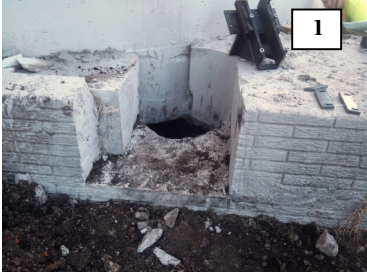
1. Prior to ECP Steel Pier™ installation, access for the pier brackets and pipes were made. Most of the steel piers were installed on the outside of the silo, but where there were obstructions outside; the piers were installed from the inside of the silo.

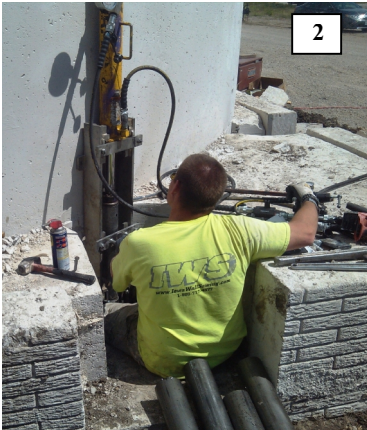
2. The PPB-350 Footing Brackets were installed and bolted in place with the bracket bearing plates in contact with the undersides of the footings. The technician is shown installing the 3-1/2 inch diameter pier pipe into the soil until suitable firm bearing was encountered. Once the bedrock was reached at depths ranging from 35 to 50 feet, the technician installed 25 feet of 4 inch diameter sleeve over the pier pipe to stiffen the pier shaft and strengthen the coupled joints. Following the pipe and sleeve installation, each placement was proof tested to 60,000 pounds to verify the competency of the load bearing stratum.

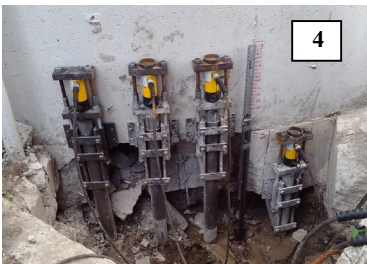
3. Once all of the piers were installed and proof tested, hydraulic rams applied 48,000 pounds of force at each placement simultaneously to recover the lost elevation. The load at each placement location was monitored by a pressure gauge.

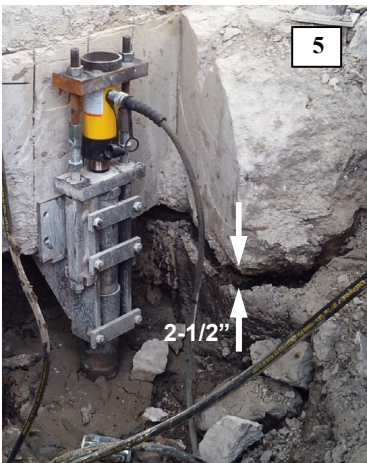
4. Lifting the silo was accomplished by placing a 25 ton hydraulic ram between the top of the pier pipe and a lifting assembly that was attached to each pier bracket.

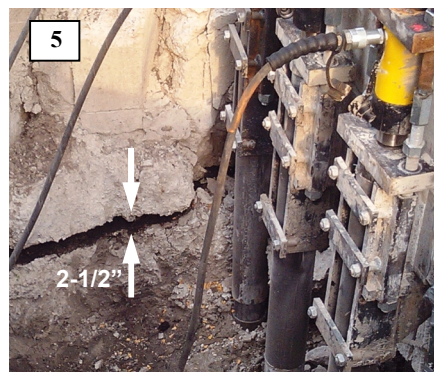
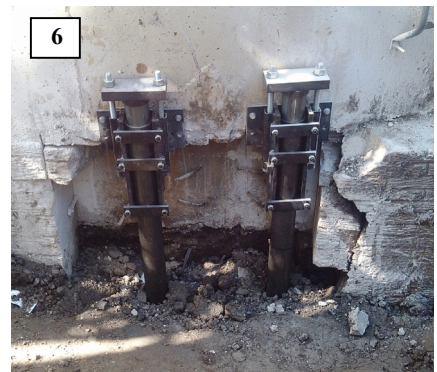
Disturbed soil in the area of work was replaced and concrete that was removed for access to the foundation was replaced. Drainage corrections insured that the cause of the settlement was removed.

The Model PPB-350 ECP Steel Piers™ were installed on this site using vibration free hydraulics to achieve depths between 35 and 50 feet below grade where end bearing was encountered. Once end bearing resistance was found, a proof test was applied to each pier. Depending upon where the piers are mounted on the structure, proof test forces ranged from 56,000 to 66,000 pounds. All testing was performed prior to placing the ECP Steel Piers™ into service.
