Case History

ECP Steel Piers™ PPB-350,
PPB-300 & PPB-250

Sewer Line Leak Under Slab, No Problem?...

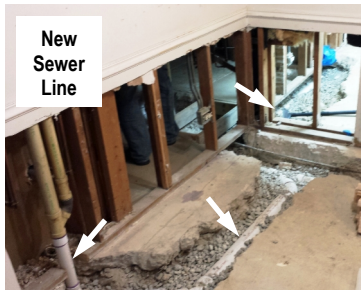
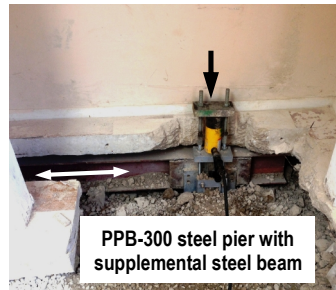
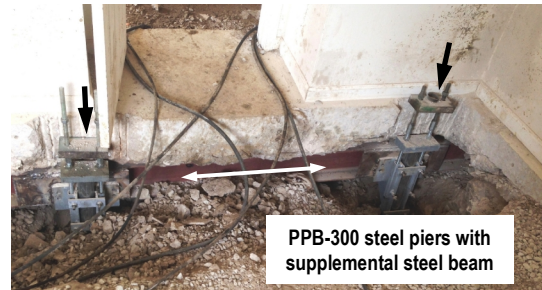
The engineer specified 25 PPB-350 steel piers that were generally located on the perimeter where the structural loads were highest. This product consists of an under footing bracket and 3-1/2 inch diameter pier pipe. Twelve PPB-300 systems with 2-7/8 inch diameter pier sections were located under interior bearing walls. Eleven PPB-250 interior pier systems were installed under non-load bearing walls.

the floors. Forty-eight ECP Steel Piers™ were used to raise this structure and recover lost elevation. Some of the piers required supplemental steel beams under portions of the building that had insufficient concrete beams. US Waterproofing also replaced approximately 3,000 square feet of concrete slab following the pier installations and restoration to original elevation.
