# The First Law of Foundation Stability: Buildings Built on Land Fill will Settle

Jackson County, Florida

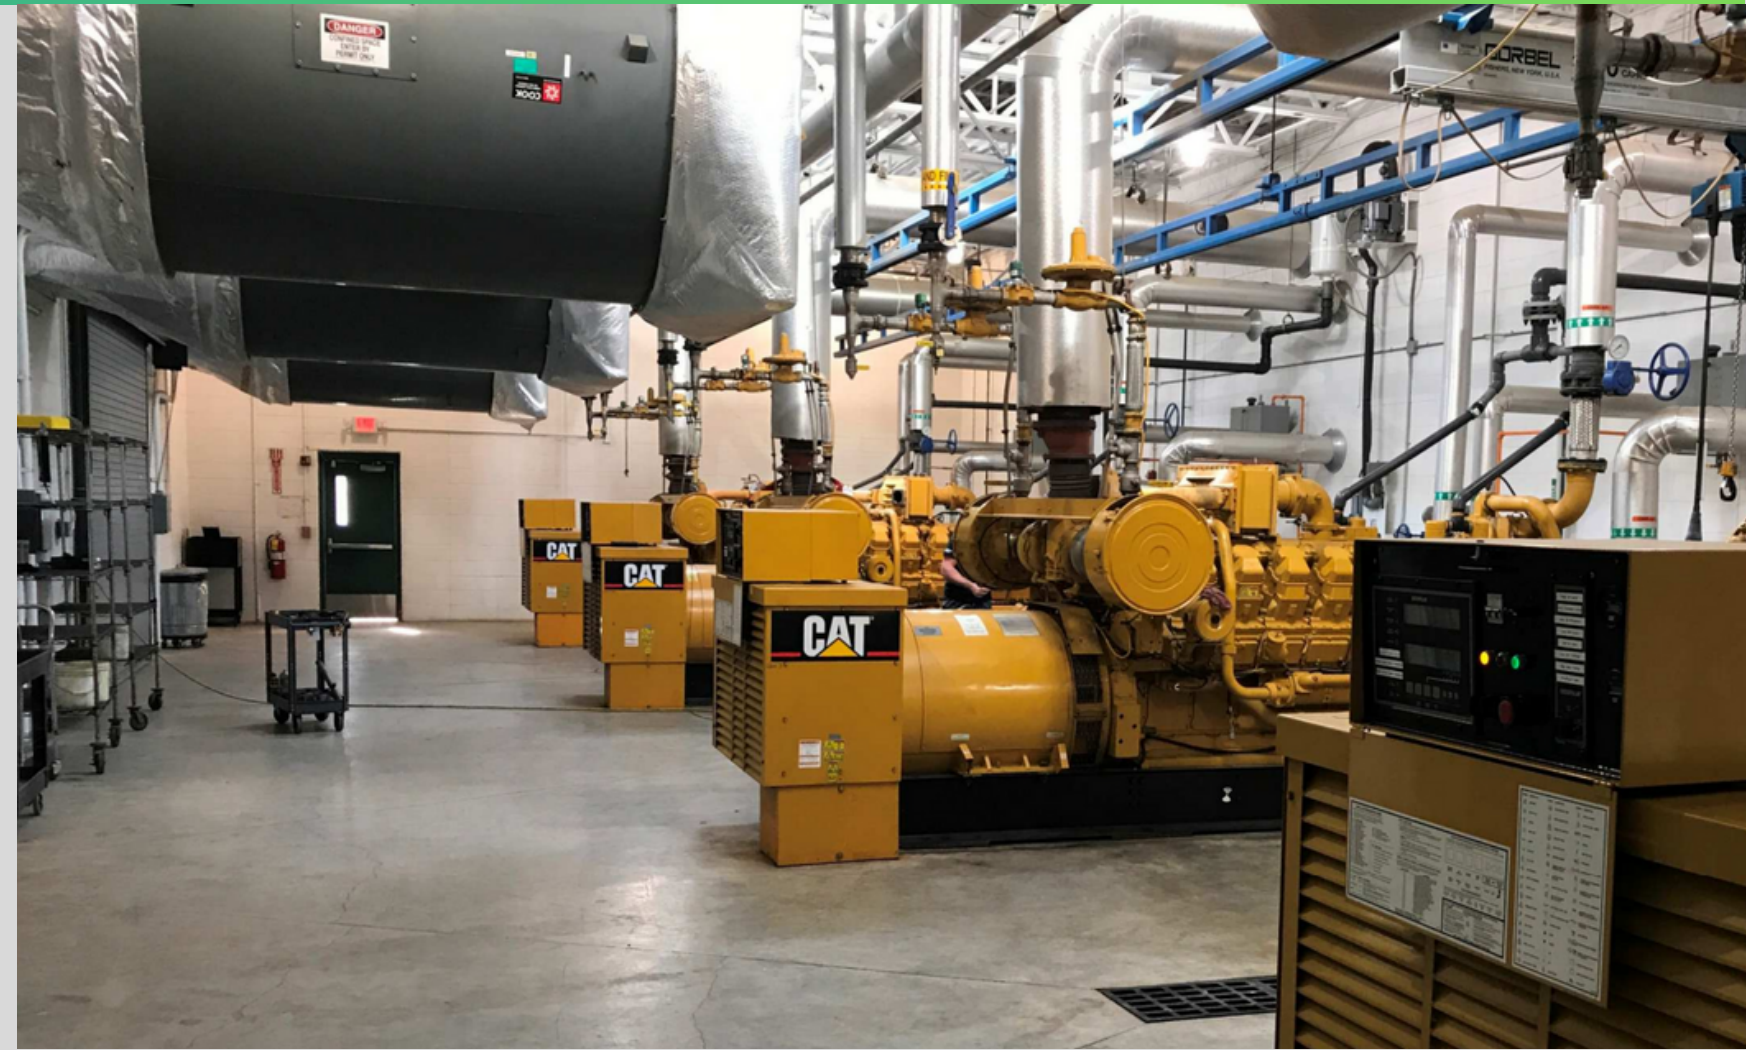
This Renewable Energy Facility Building was built in 2004 on land fill. The 20,000 square foot single story building was constructed with slab on grade foundation, concrete block walls and steel truss roof supports. The construction documents showed that the building is supported on a 30 inch wide continuous grade beam situated 28 inches below the finished floor slab elevation. Concrete pads are present under multiple large 16 cylinder Caterpillar generators and other pieces of equipment, and equipment supports.

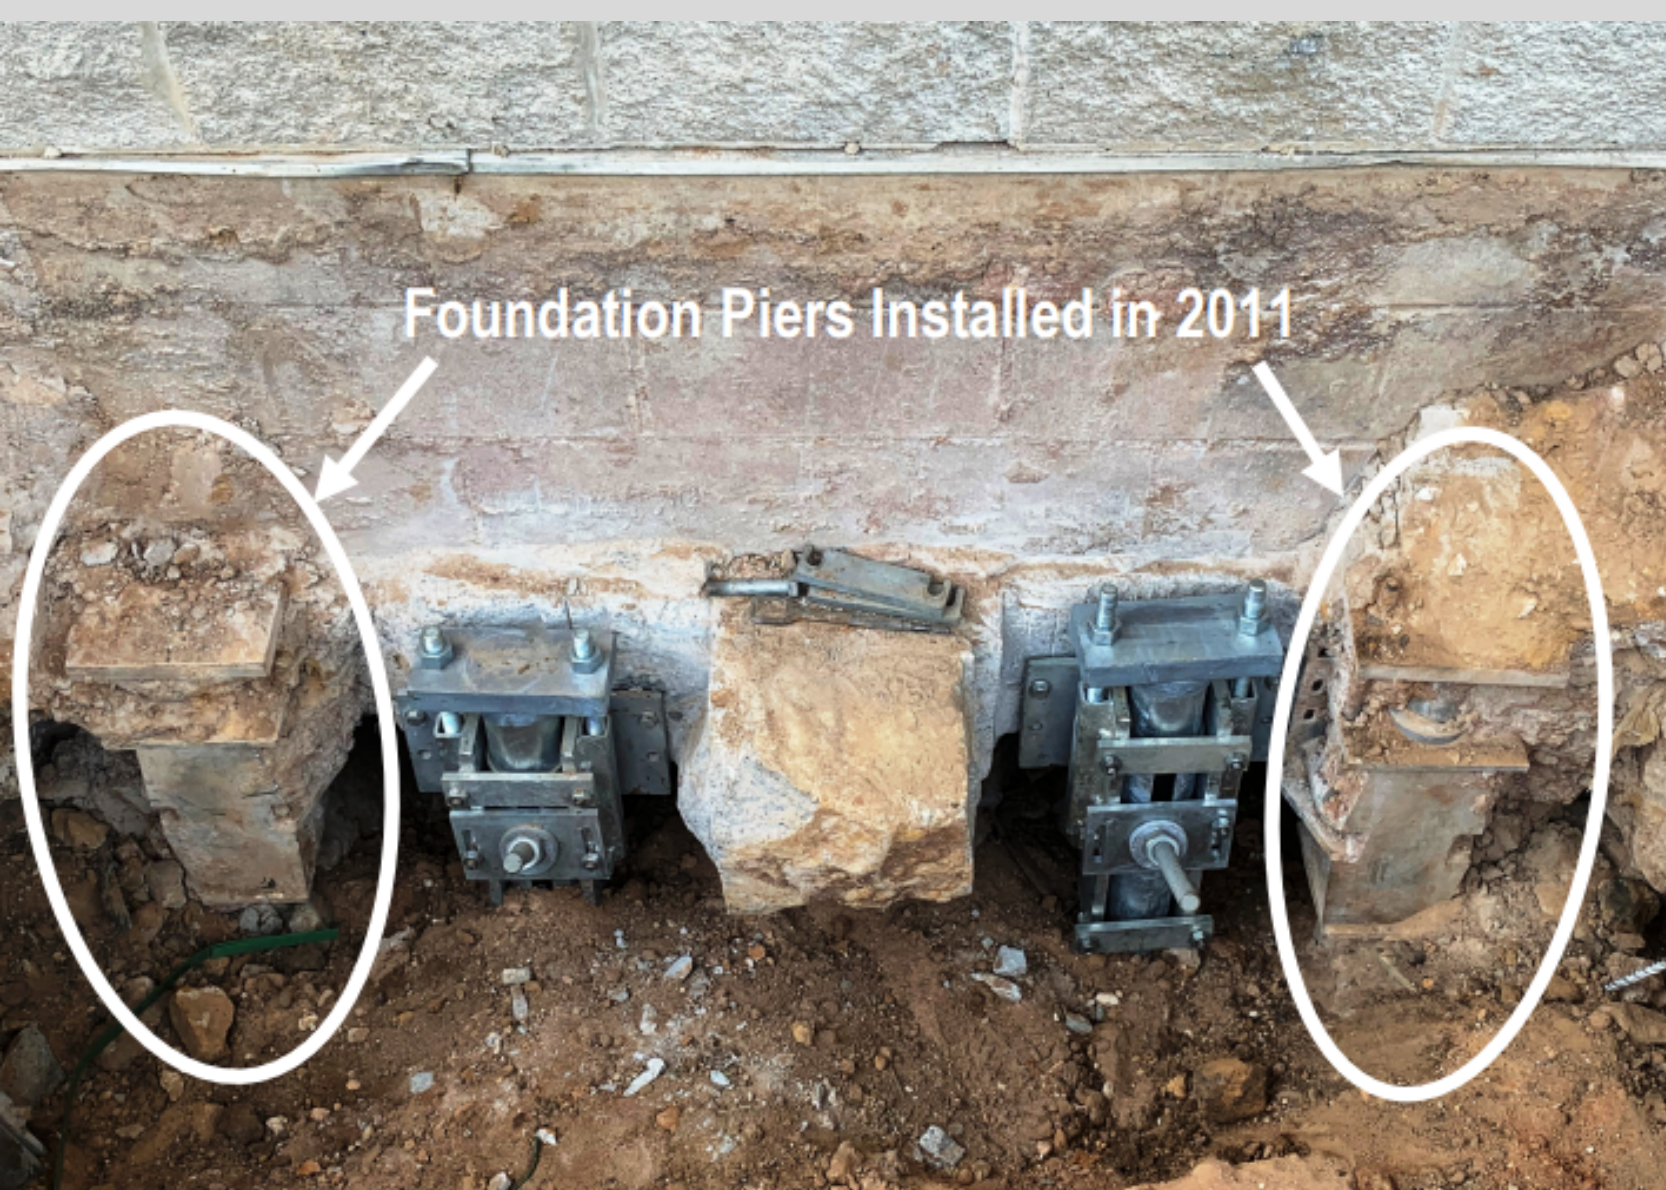
Google Earth historical aerial imagery showed the building straddles the west edge of a closed landfill cell. The original building plans have a detail for the over excavation of the unsuitable land fill materials. Evidence shows that this specification was skipped by the original contractor. The existing building shows signs of foundation movements and instability. These appeared as separations between the wall and floor slab, stair-step fractures and vertical cracks in the masonry work and differential movement with cracks in the floor slab. The east wall of the building showed lateral movement toward the east along with wall rotation causing several roof joists to pull away from the west wall bearing plates.
