CASE HISTORY ECP PPB-350-WM Steel Piers™
AND HMI-RR401 POLYURETHANE FOAM

2.2 Million Pounds of Rail Inspection Pit Sections Were Raised with ECP Steel Piers™ and Voids Filled With High Density Polyurethane Foam

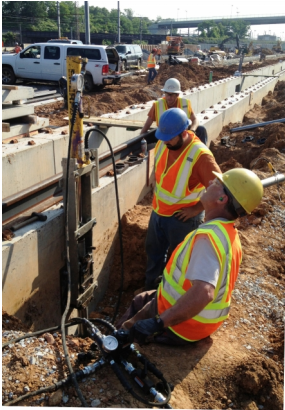
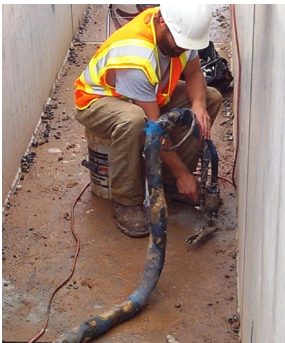
Photographs: At the top and middle left are views showing the installation of the ECP PPB-350-WM Steel Piers™. The pier bracket is mounted to the side wall of the inspection pit section and the three inch diameter steel pier pipe is driven to suitable end bearing and load tested with the yellow hydraulic cylinder shown. The installer monitors the force on the pipe by observing the hydraulic gauge shown in the middle photo.
