Surprise, No Footing

Apartment Building Restored with Helical Underpinning

Green, Ohio

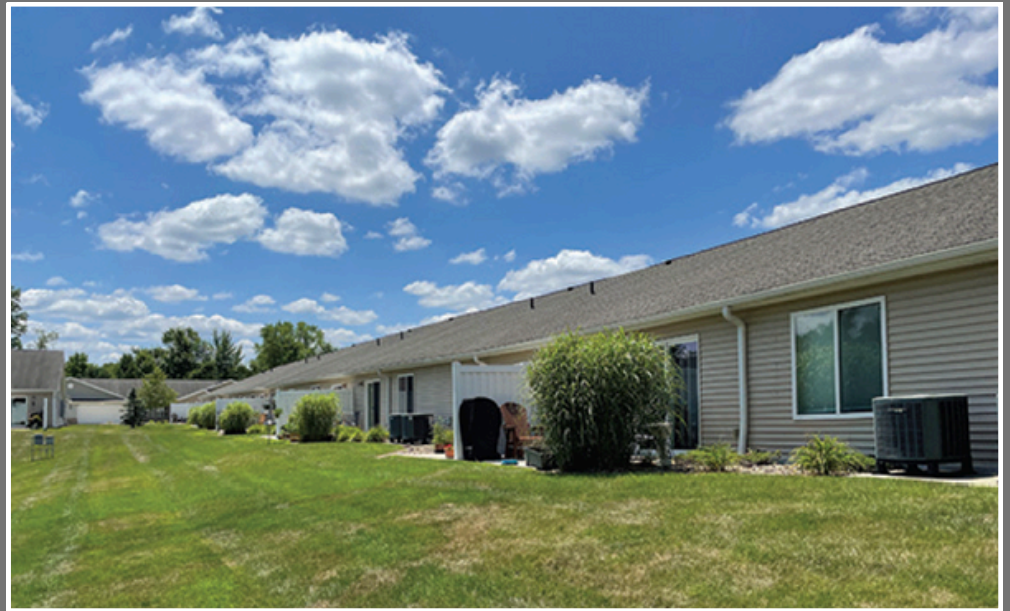
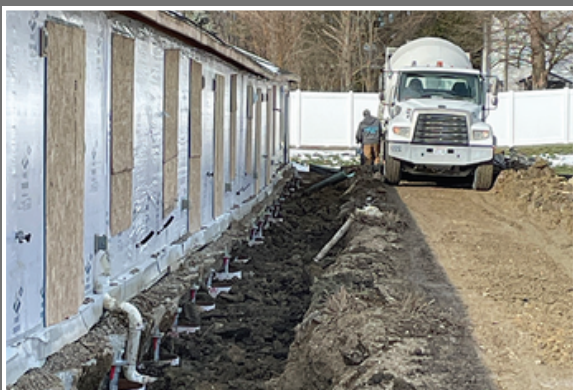
The owners hired a surveyor to measure the level of the building and they determined the foundation to be roughly a foot out of level over its entire 300 foot length, mostly along the rear of the building.

Subsequent soil testing revealed that the rear of the building was situated on fill atop soft peat and organic clay.

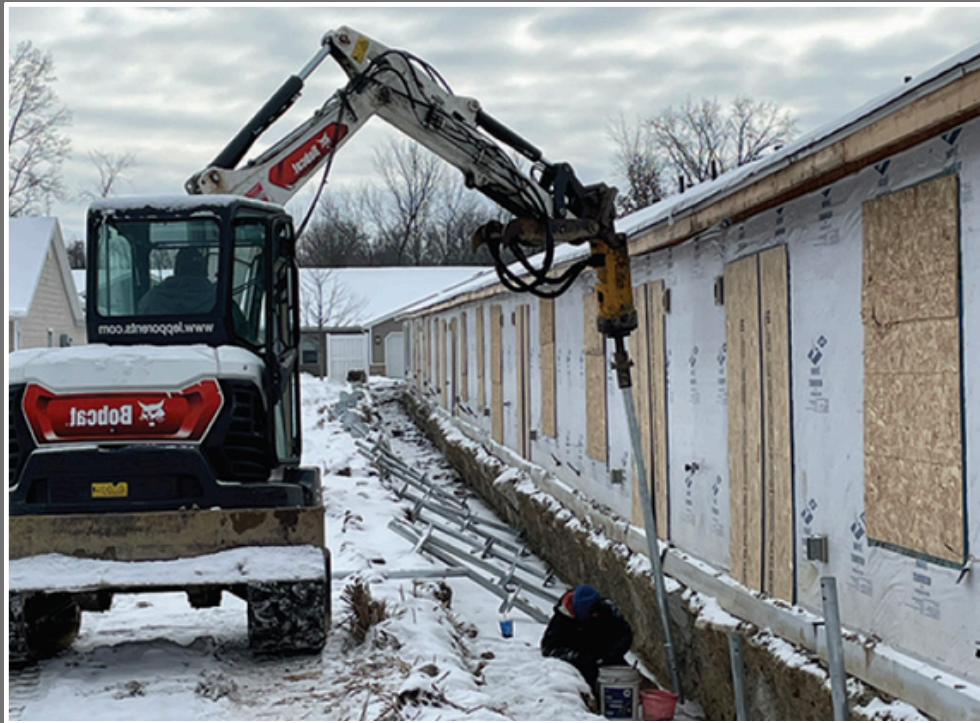
During this evaluation it was determined that the common walls separating the units did not have footings as indicated on the plans. Based on that finding the owners decided to use slab jacking to raise the concrete floor under the common walls. The process of releveling the structure to an acceptable level required underpinning the foundation with helical piles, jacking the foundation and stabilizing it against further movement, cutting away much of existing framing to facilitate releveling, and slab jacking to bring the slab back up to level.

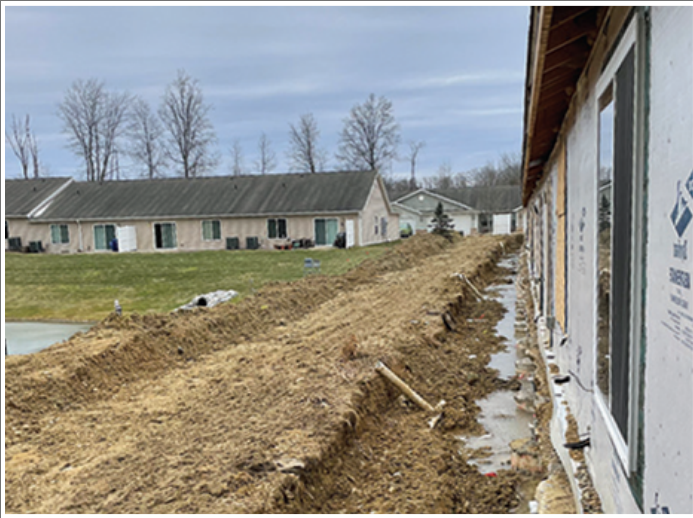
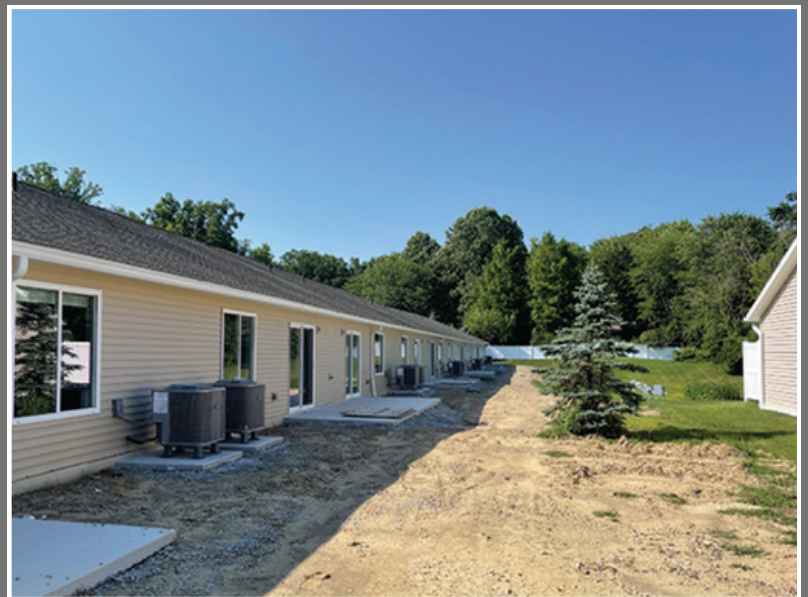
After all the residents were relocated and utilities removed from the rear of the building, Midwest Foundation Tech installed 28 helical piles next to the 3-foot deep trench footings. The helical piles utilized a 10"-12"-14" helical configuration, installed to an average depth of 24 feet using a Bobcat E-50 mini-excavator with a gearhead rated to 9,500 foot-lbs. After connecting the screw piles to the footing it was jacked up 4 inches and stabilized. Greene Concrete Leveling raised the floor and interior partition wall some more to achieve an acceptable level condition. The interior framing and finishing was reestablished by carpenters.
