CASE HISTORY

ECP HELICAL TORQUE ANCHORS™

Helical Torque Anchor™ Piles Support Post Office Expansion Denver, Colorado

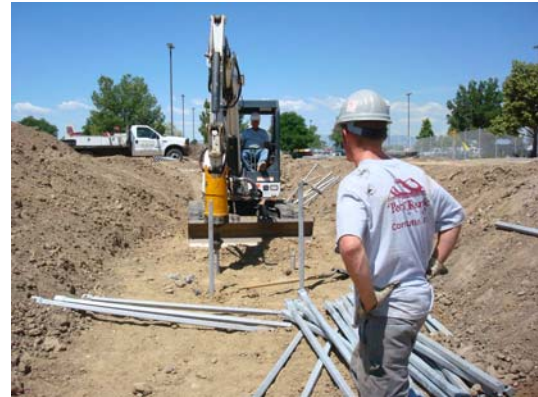
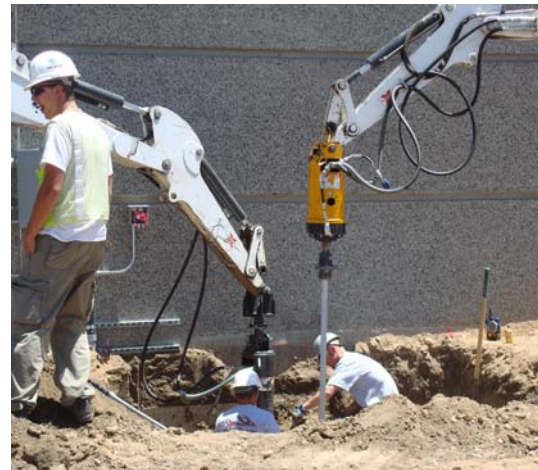
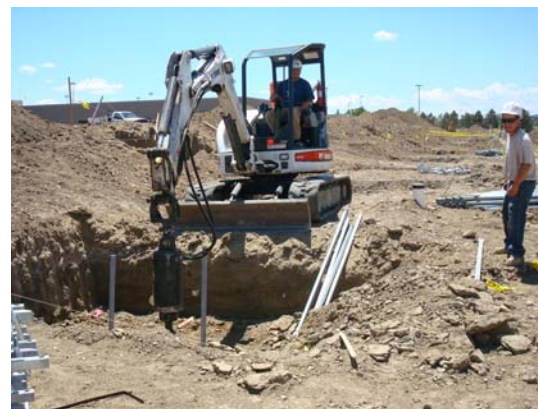
Pile Installation

The ECP Model TAF-175 Torque Anchor™ solid square shaft helical pile was installed at each placement to a minimum depth requirement of 45 feet below grade. The pile configurations varied due to soil borings encountering very dense soils at 10 to 15 feet deep on a portion of the site. At these placement locations, the smaller plate configuration was used to allow the pile to reach the target depth before experiencing excessive shaft torsion. The target shaft torsion to provide the service load requirement of 43,500 pounds, plus a factor of safety of 2.0, was 8,700 foot-pounds.

Gray Construction was awarded the contract to construct the 162,000 square foot U.S. Post Office expansion project in Denver. Park Range Construction was selected as the certified installer of helical piles supplied by Earth Contact Products. The helical piles were arranged in clusters of three to four piles at each of the 91 concrete pile caps. The column loads on the pile caps ranged from 130,000 pounds to 174,000 pounds. During pile installation Park Range Construction provided three teams to place the helical piles per plans. The job proved to be challenging due to difficult drilling through dense soil conditions to reach the claystone bedrock at 45 to 50 feet.

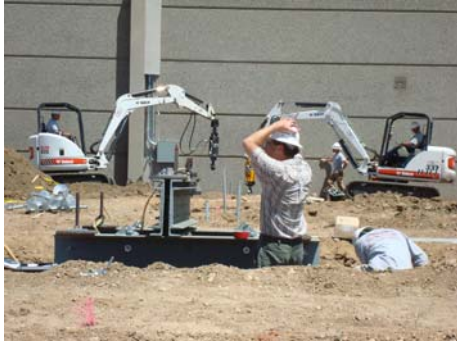
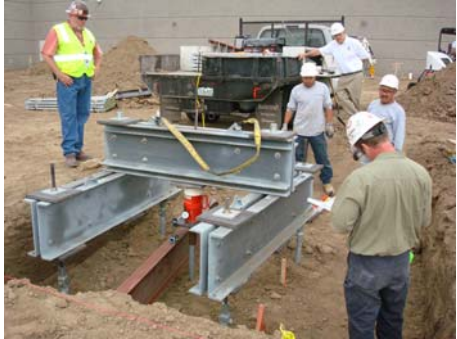
Load Testing

As part of the verification process, two static load tests were performed prior to installing the piles and two load tests during production. These tests were directed and supervised by CTL Thompson Engineering and monitored by the USPS inspector. The test procedure was conducted in close conformance with ASTM D-1143. All of the load tests were successful.
