## Handle With Care

### Delicate Approach Preserves Historic Home

Manhattan, Kansas

RESIDENTIAL PROJECT OF THE YEAR FINALIST

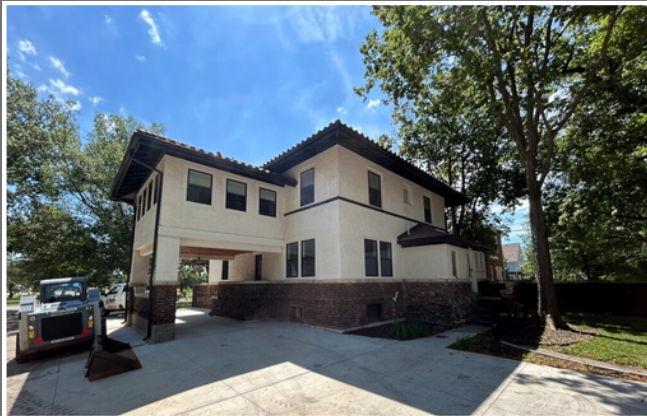
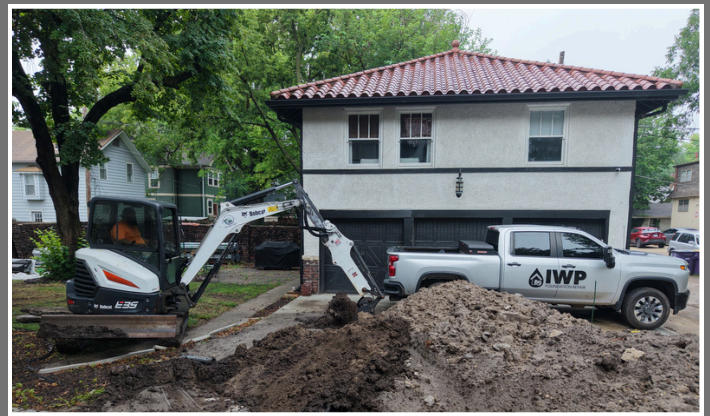
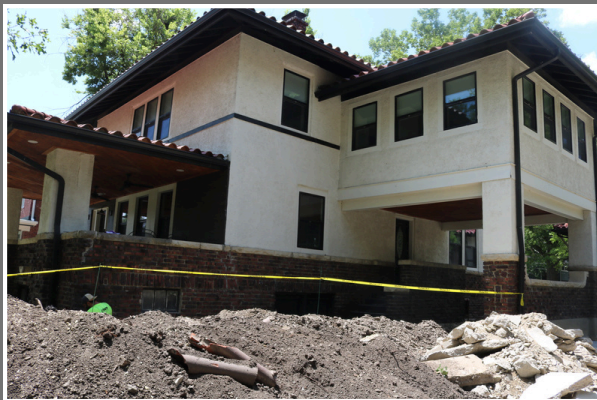
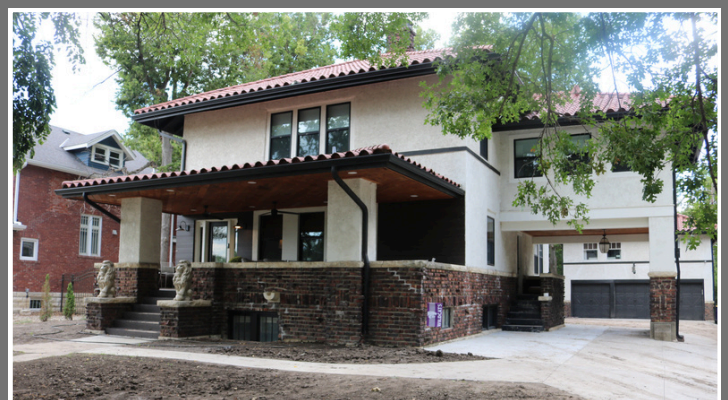
The home features a nonstandard foundation system typical of older Victorian buildings, requiring a tailored approach to stabilization. The scope of work included installing 34 3-1/2" push piers, 16 3" push piers, and 9 concentric piers, covering all sides of the home to ensure comprehensive support and long term stability.

Fortunately, Manhattan's black silty soil, which is more forgiving than the expansive clay IWP usually deals with, allowed for smooth installation conditions. Their team worked carefully to integrate the new foundation supports without compromising any of the recently completed renovations, preserving both the structural integrity and the homeowner's investment.

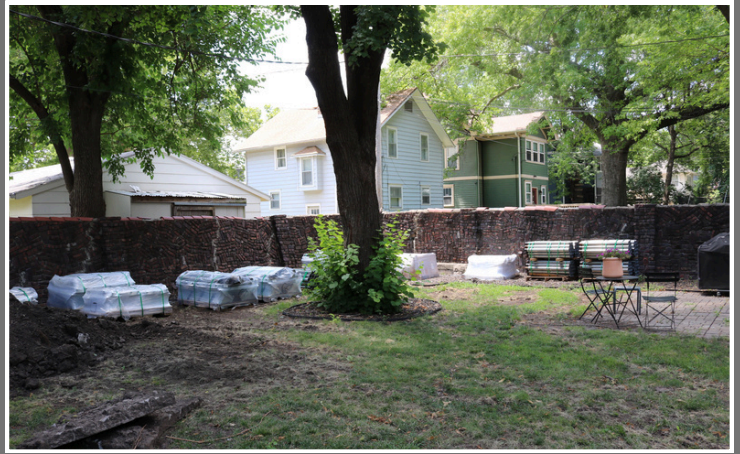
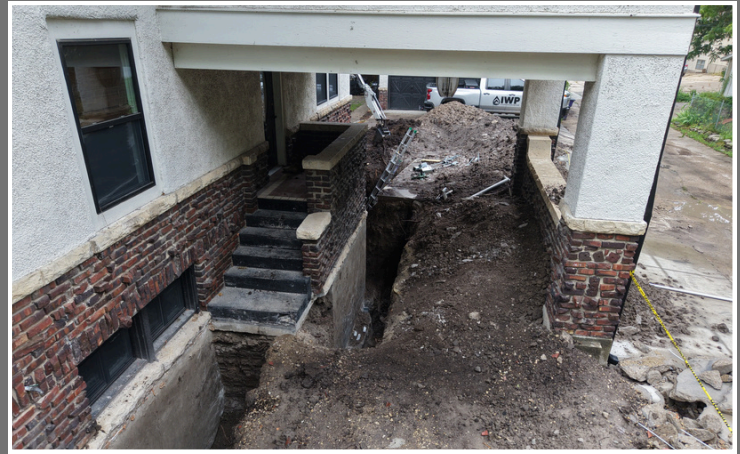
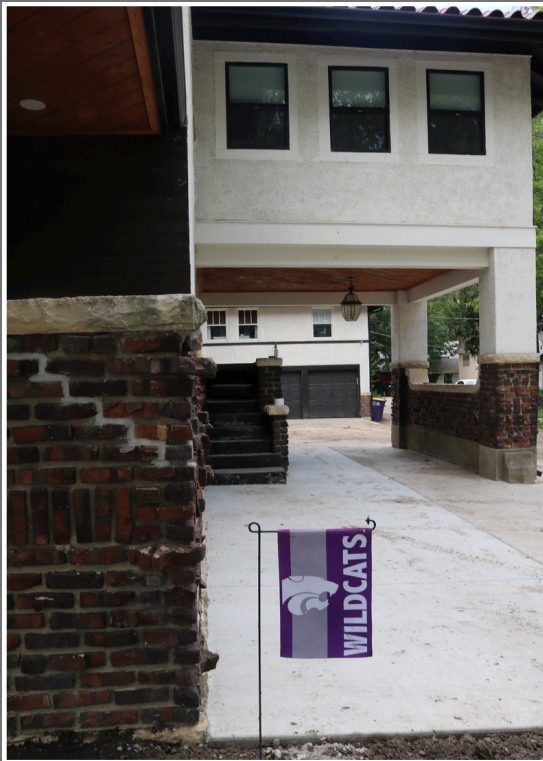
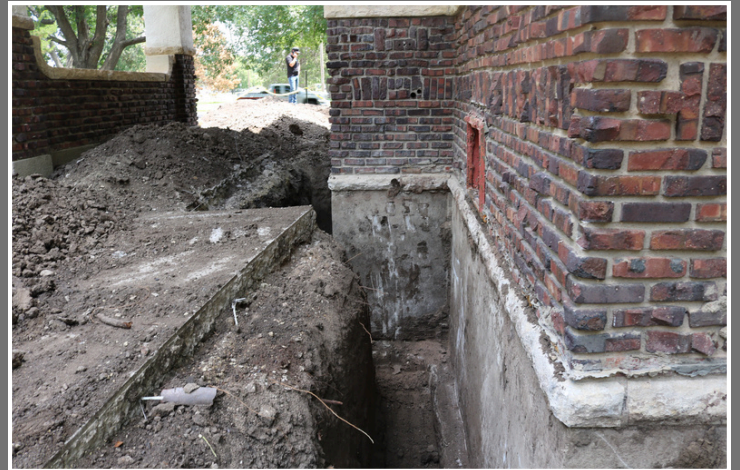
This project presented several physical and logistical challenges due to the age and layout of the home. One of the most significant issues was tight excavation access around the perimeter, which made maneuvering equipment and completing pier installation more difficult, especially near neighboring property lines and structures.

Additionally, there was an abundance of concrete that needed to be removed before pier work could begin, including old sidewalks, steps, and previous patchwork around the foundation. This added considerable prep time to the job. During excavation, the crew also encountered a broken sewer line, which created an unexpected complication and required immediate attention. Finally, the sheer volume of soil dug up from the excavation introduced further difficulties in keeping the site organized and manageable throughout the project.
