CASE HISTORY

ECP STEEL PIERS™
ECP TORQUE ANCHORS™

Removal of Fuel Tanks near an Existing Structure Brooklyn Center, MN

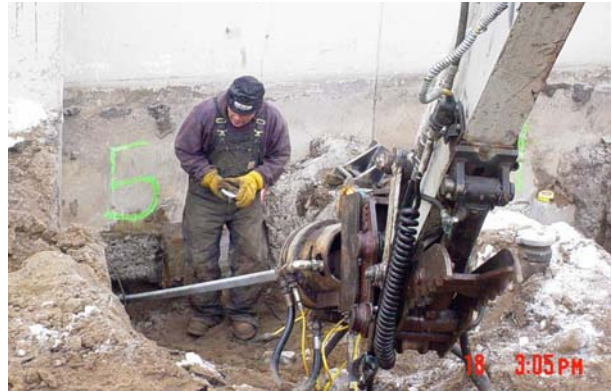
The photo at upper right shows a hydraulic motor installed on a backhoe being used advance a Torque Anchor™ tieback under the structure. Once accomplished, technicians

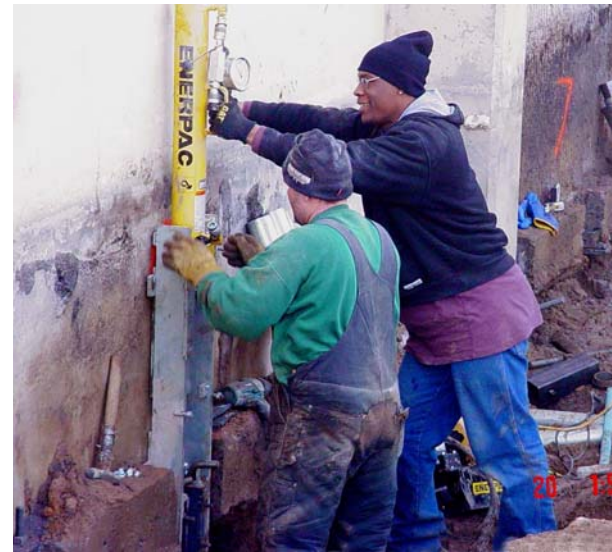
installed the pier driving equipment against the wall. Notice that the footing has been carefully notched to place the pier bracket under the structural wall. The final configuration of ECP Steel Pier™ and Torque Anchor™ tieback is shown left.

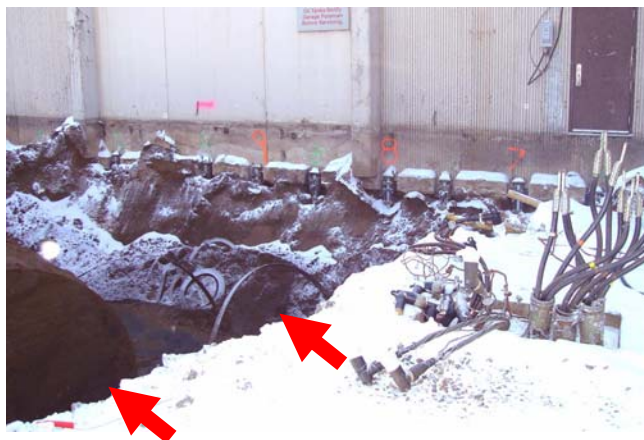
Once the supplemental supports were in place, excavation and removal of the fuel tanks began. The progress is shown below. The photograph at lower left shows the tops of the two fuel tanks. The pier placement locations along the wall are also visible. The photograph at lower right demonstrates the size of the fuel tanks and why the engineer chose ECP products to stabilize the building during tank removal operations.
